Mock Inspection Report

Colorado Springs, CO, USA

Jun 5, 2025

Performed by John Pharris

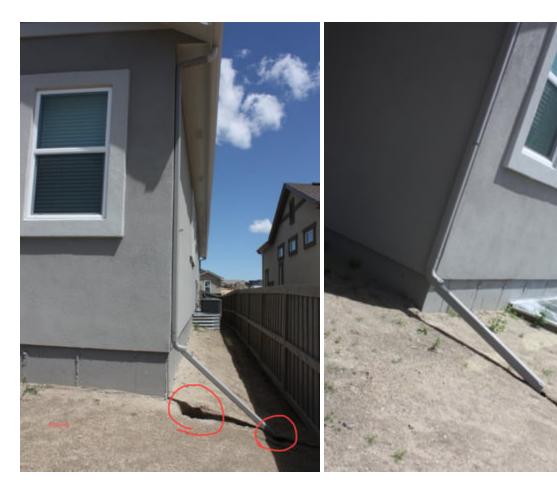
At the time of inspection no defects were observed. Recommendation is to have concrete blocks installed to help prevent washout. Home owner is in process of having landscaping installed.
