Mock Inspection Report

Colorado Springs, CO, USA

Jun 5, 2025

Performed by John Pharris

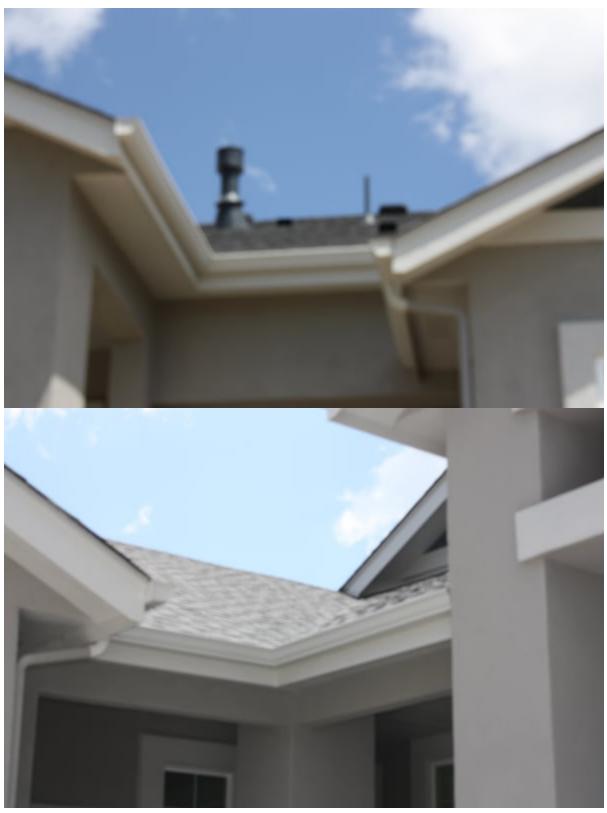
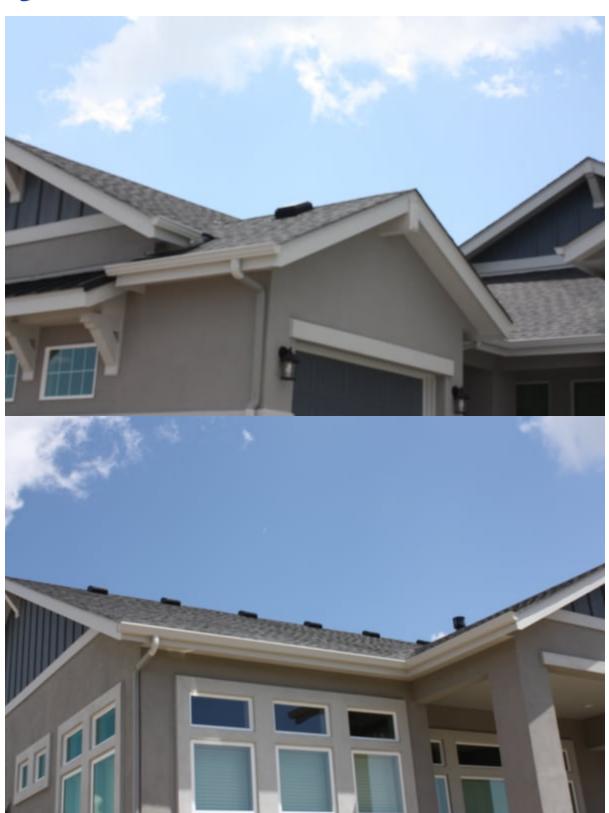
Roof-Covering Materials	No Defect(s) Observed
At the time of inspection, roof was observed fron	n the ground level.

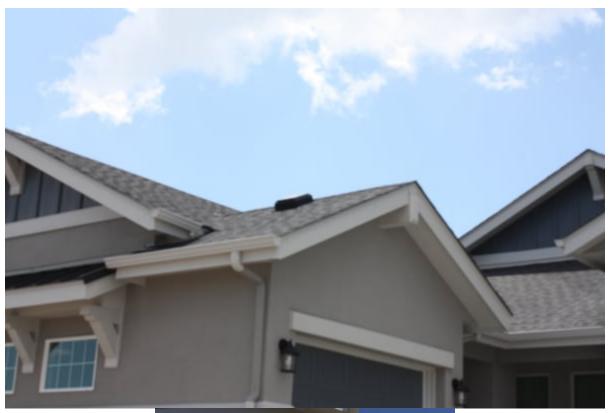
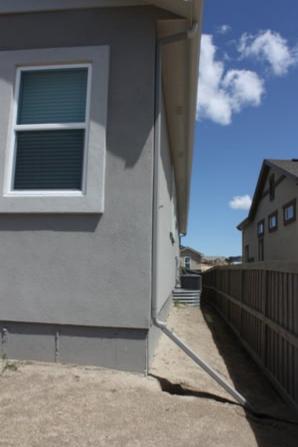
Gutters	No Defect(s) Observed
At the time of inspection no defects were obs	served.

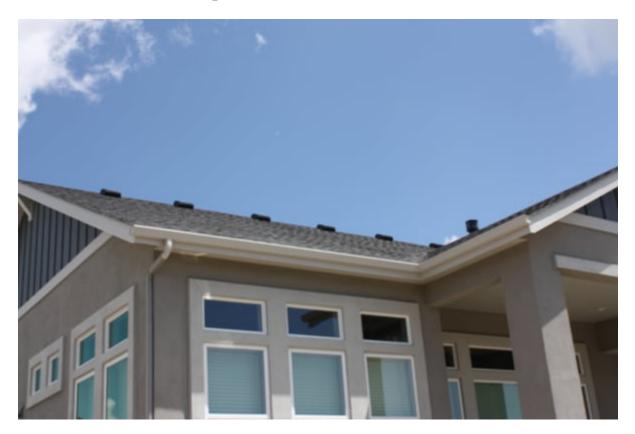
- Asphalt Shingle
- At the time of inspection no defects were observed. This is a new home, less than 6 months old, pictures do not show how well the roof looks.

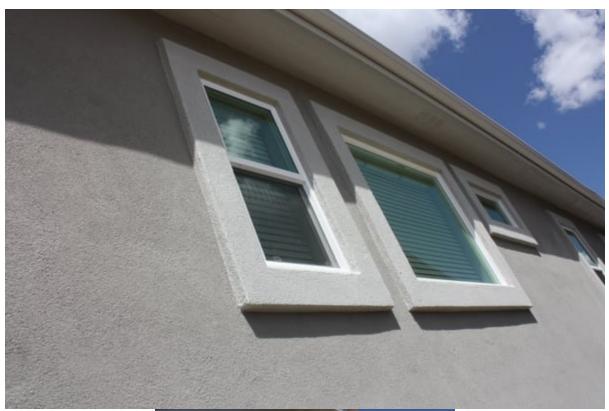
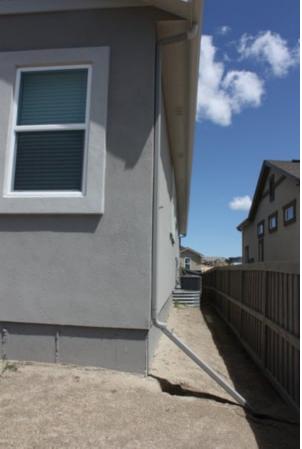
Eaves, Soffits and Fascia	No Defect(s) Observed
At the time of inspection no defects were observed.

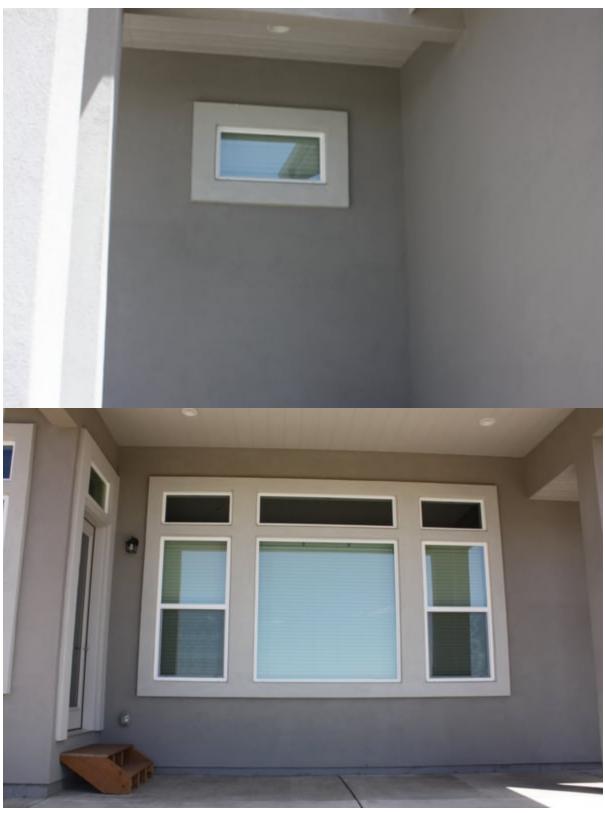
Windows (a representative number)	No Defect(s) Observed
At the time of inspection no defects were observed.

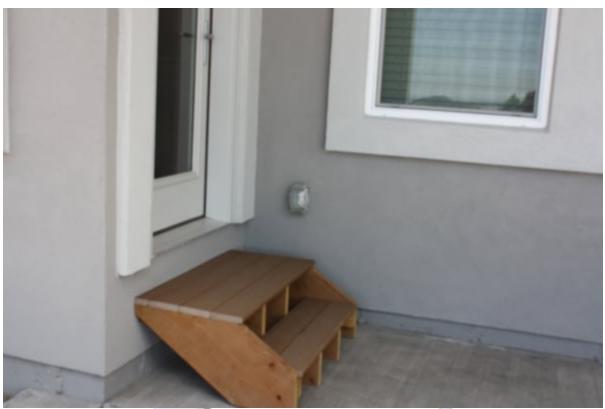
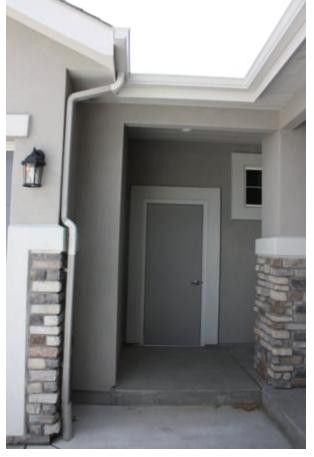
Stairs, Steps, Stoops, Stairways and Ramps	No Defect(s) Observed
At the time of inspection no defects were observed.

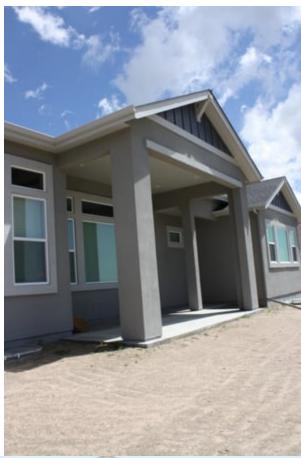
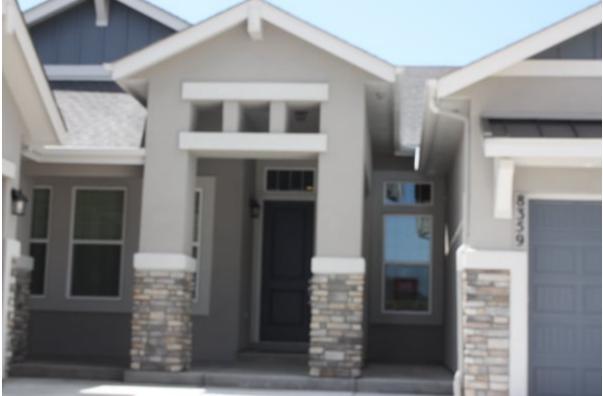
Porches, Patios, Decks, Balconies and Carports	No Defect(s) Observed
At the time of inspection no defects were observed.

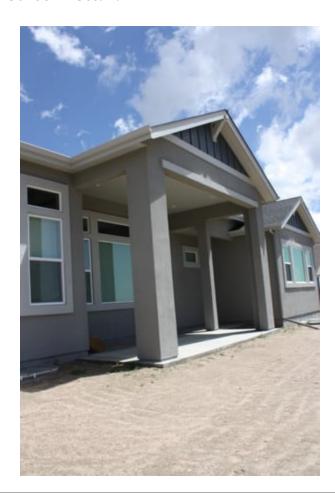
At the time of inspection no landscaping installed: homeowner has a contractor scheduled to install.

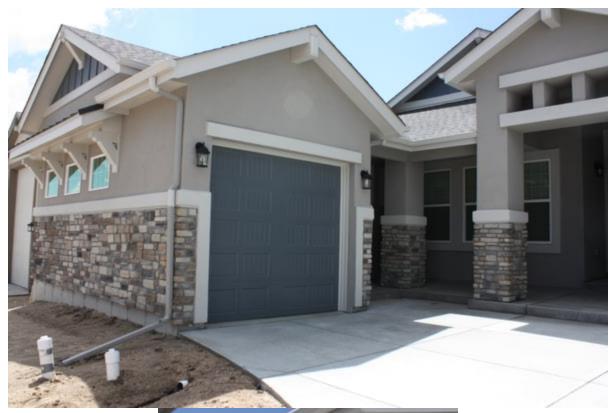
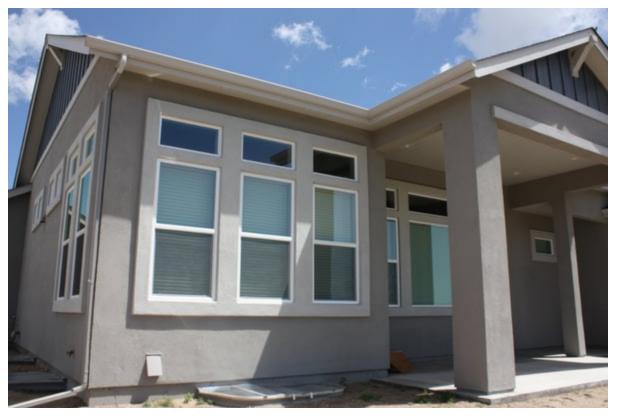
- Stucco
- Masonry, Brick or Stone
 At the time of inspection no defects were observed.

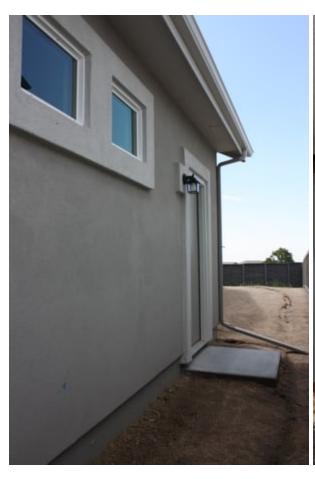
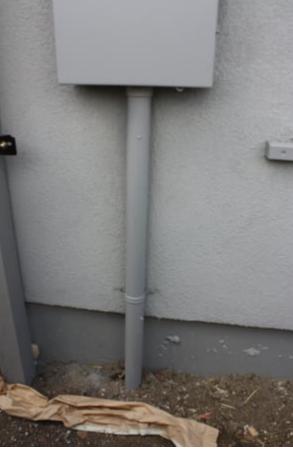
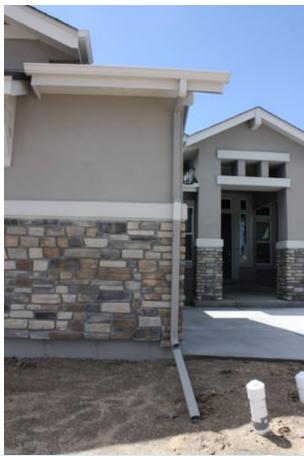
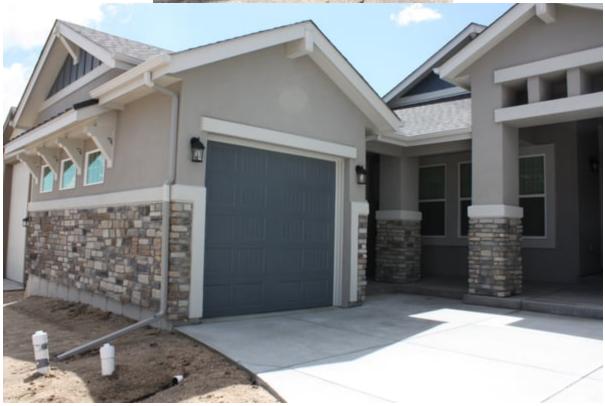
Foundation

At the time of inspection no defects were observed.

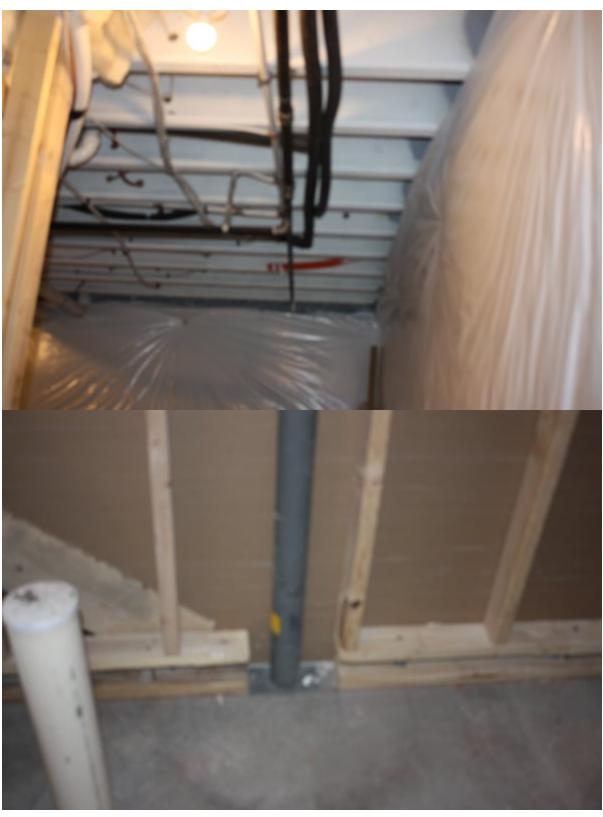
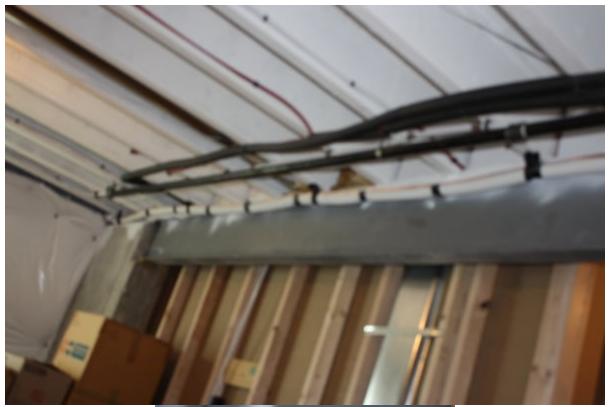
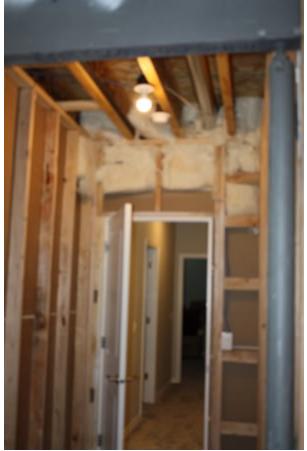
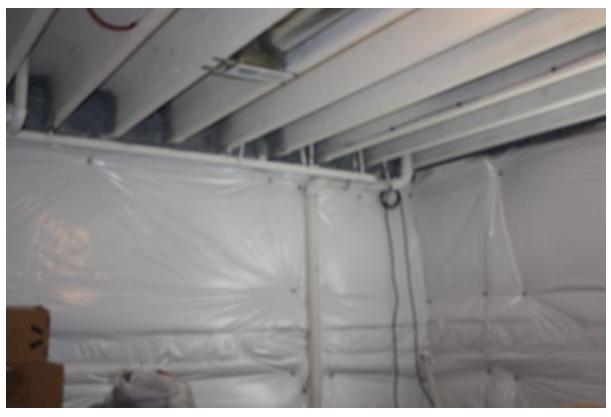
Structural Components	No Defect(s) Observed
At the time of inspection no defects were observed.

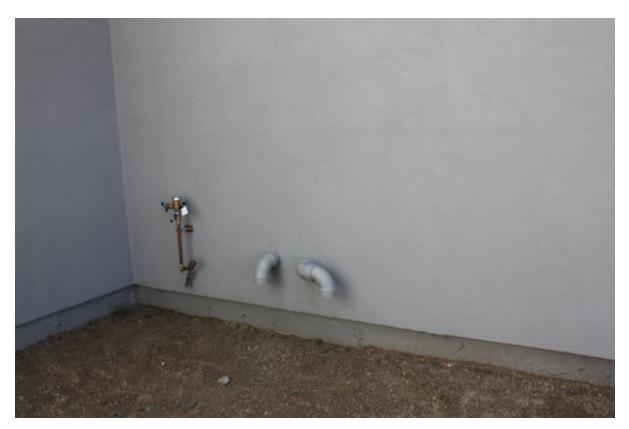
The Type of Foundation

• At the time of inspection concrete.

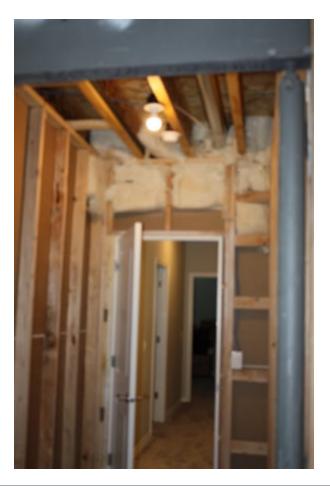
The Location of the Access to the Under-Floor Space

• Location is in the basement; unfinished space was present at the time of inspection.

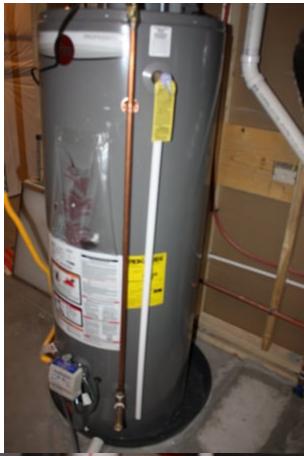
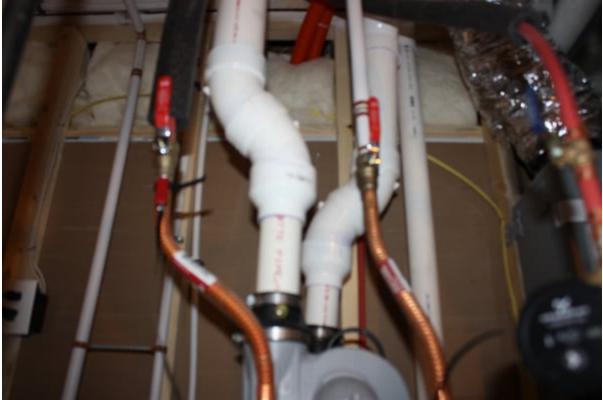
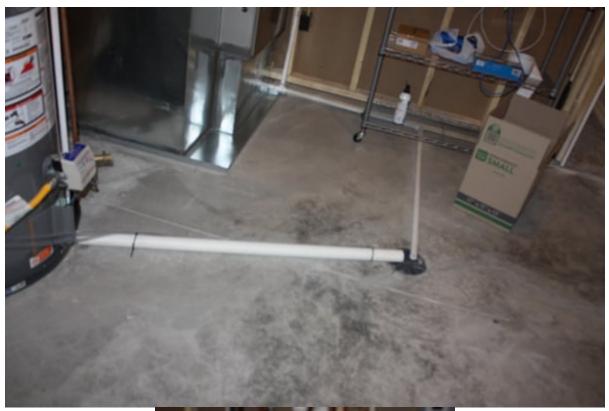
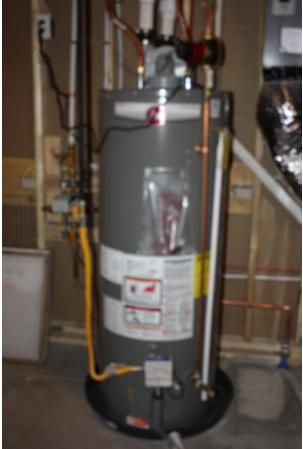
Water Heating Equipment (including the energy

source, venting connections, emperature/pressure-relief (TPR) valves, Watts	No Defect(s) Observed	
210 valves, and seismic bracing)		
at the time of inspection no defects were observed.

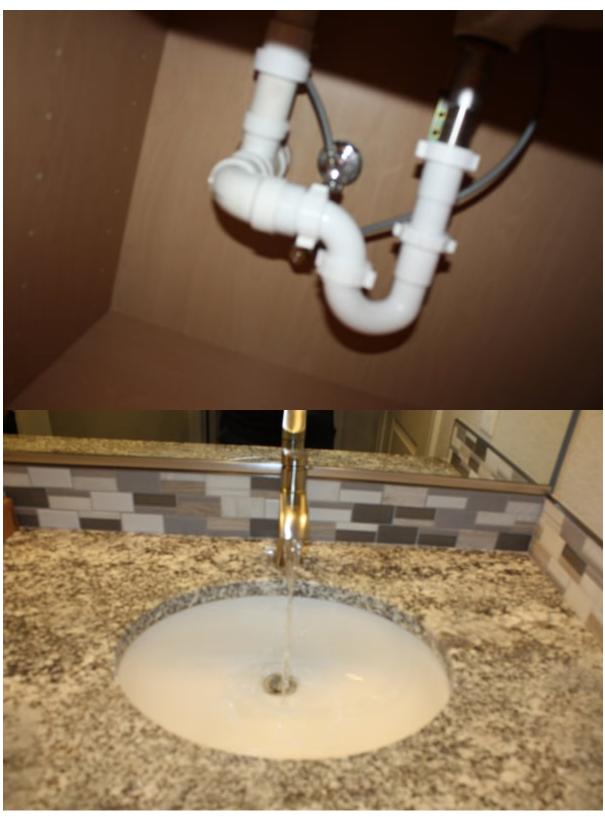
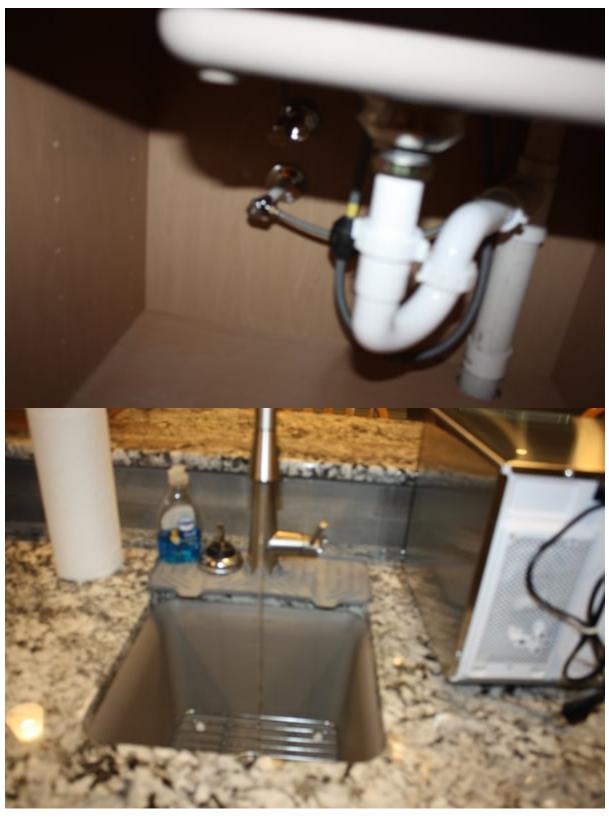
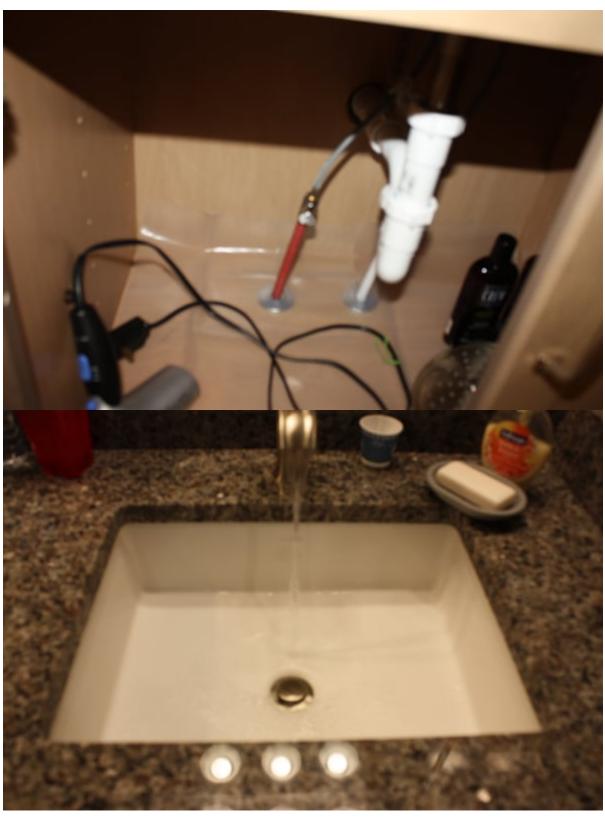
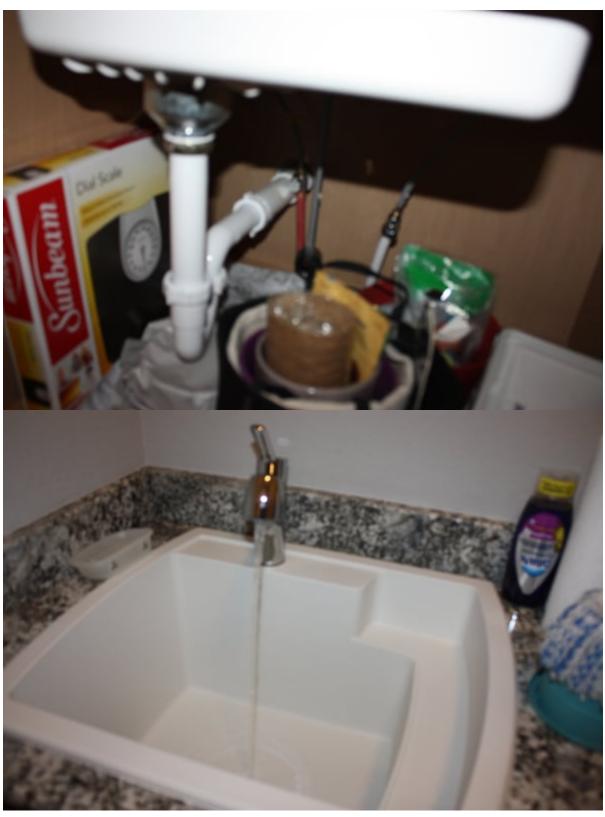
Interior Water Supply (including all fixtures and faucets, by running the water)	No Defect(s) Observed
At the time of inspection no defects were observed.

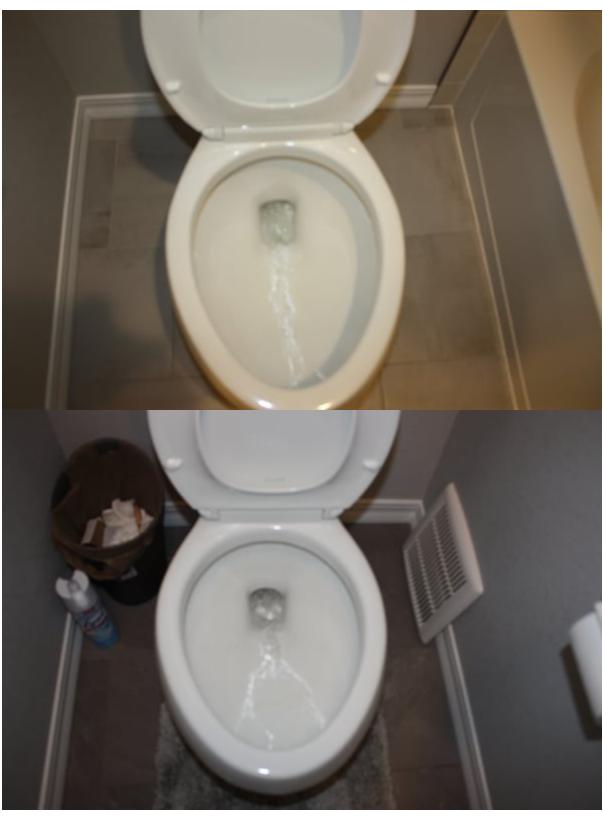
All Toilets (for proper operation by flushing)	No Defect(s) Observed
At the time of inspection no defects were observed.

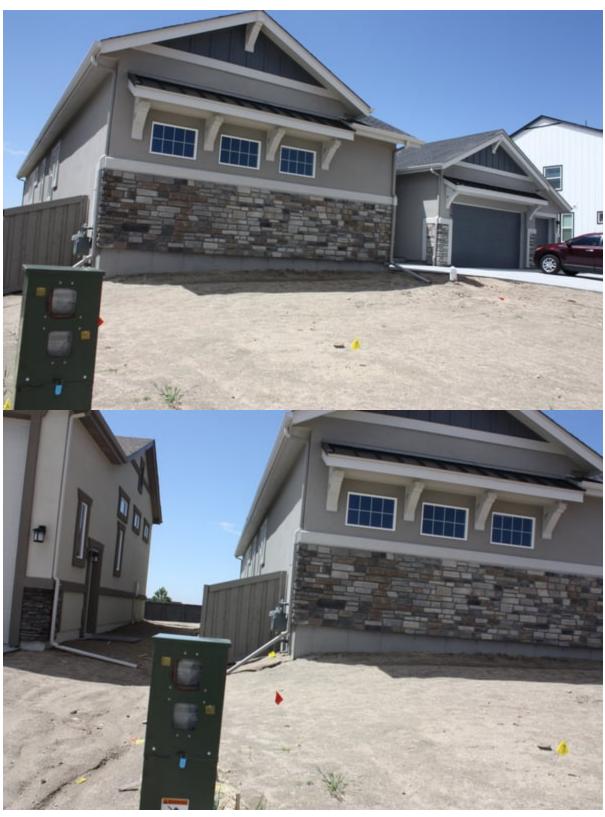
Electric Meter and Base	No Defect(s) Observed
At the time of inspection no defects were obse	erved.

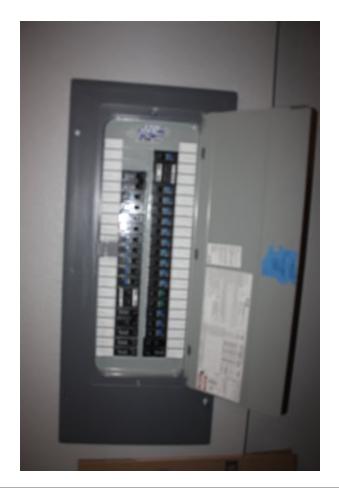
At the time of inspection no defects were observed. Tested and reset properly.

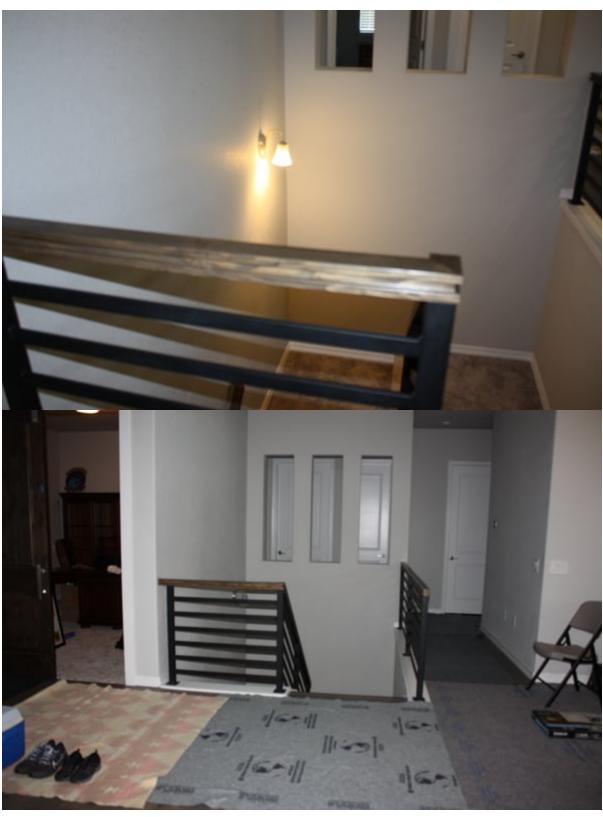
Stairs, Steps, Landings, Stairways and Ramps	No Defect(s) Observed
At the time of inspection no defects were observed.

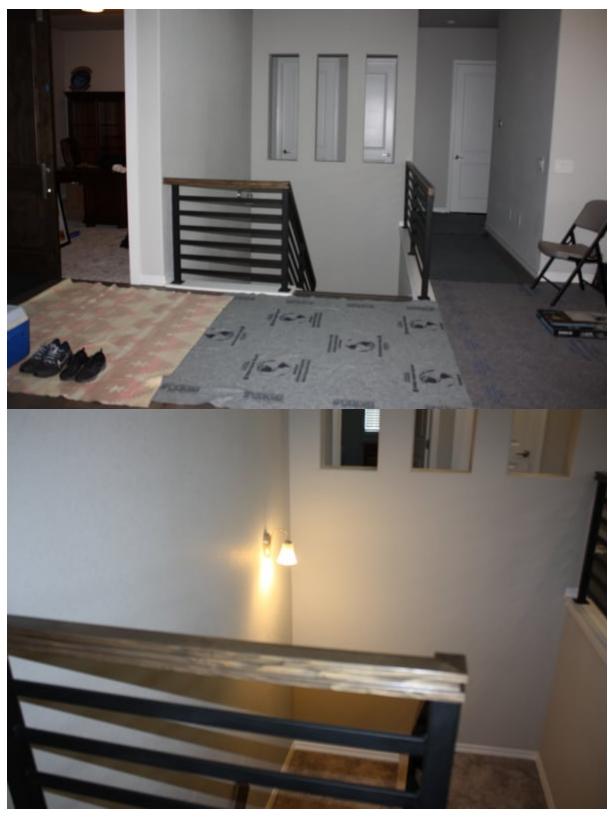
Railings, Guards and Handrails	No Defect(s) Observed
At the time of inspection no defects were observed.
